# **Friends of Eel Fall Chinook Monitoring Project**

**Report #8**

**Are There Chinook in the Eel Estuary and What Is  
The Condition of Habitat?**

**October 20, 2010**

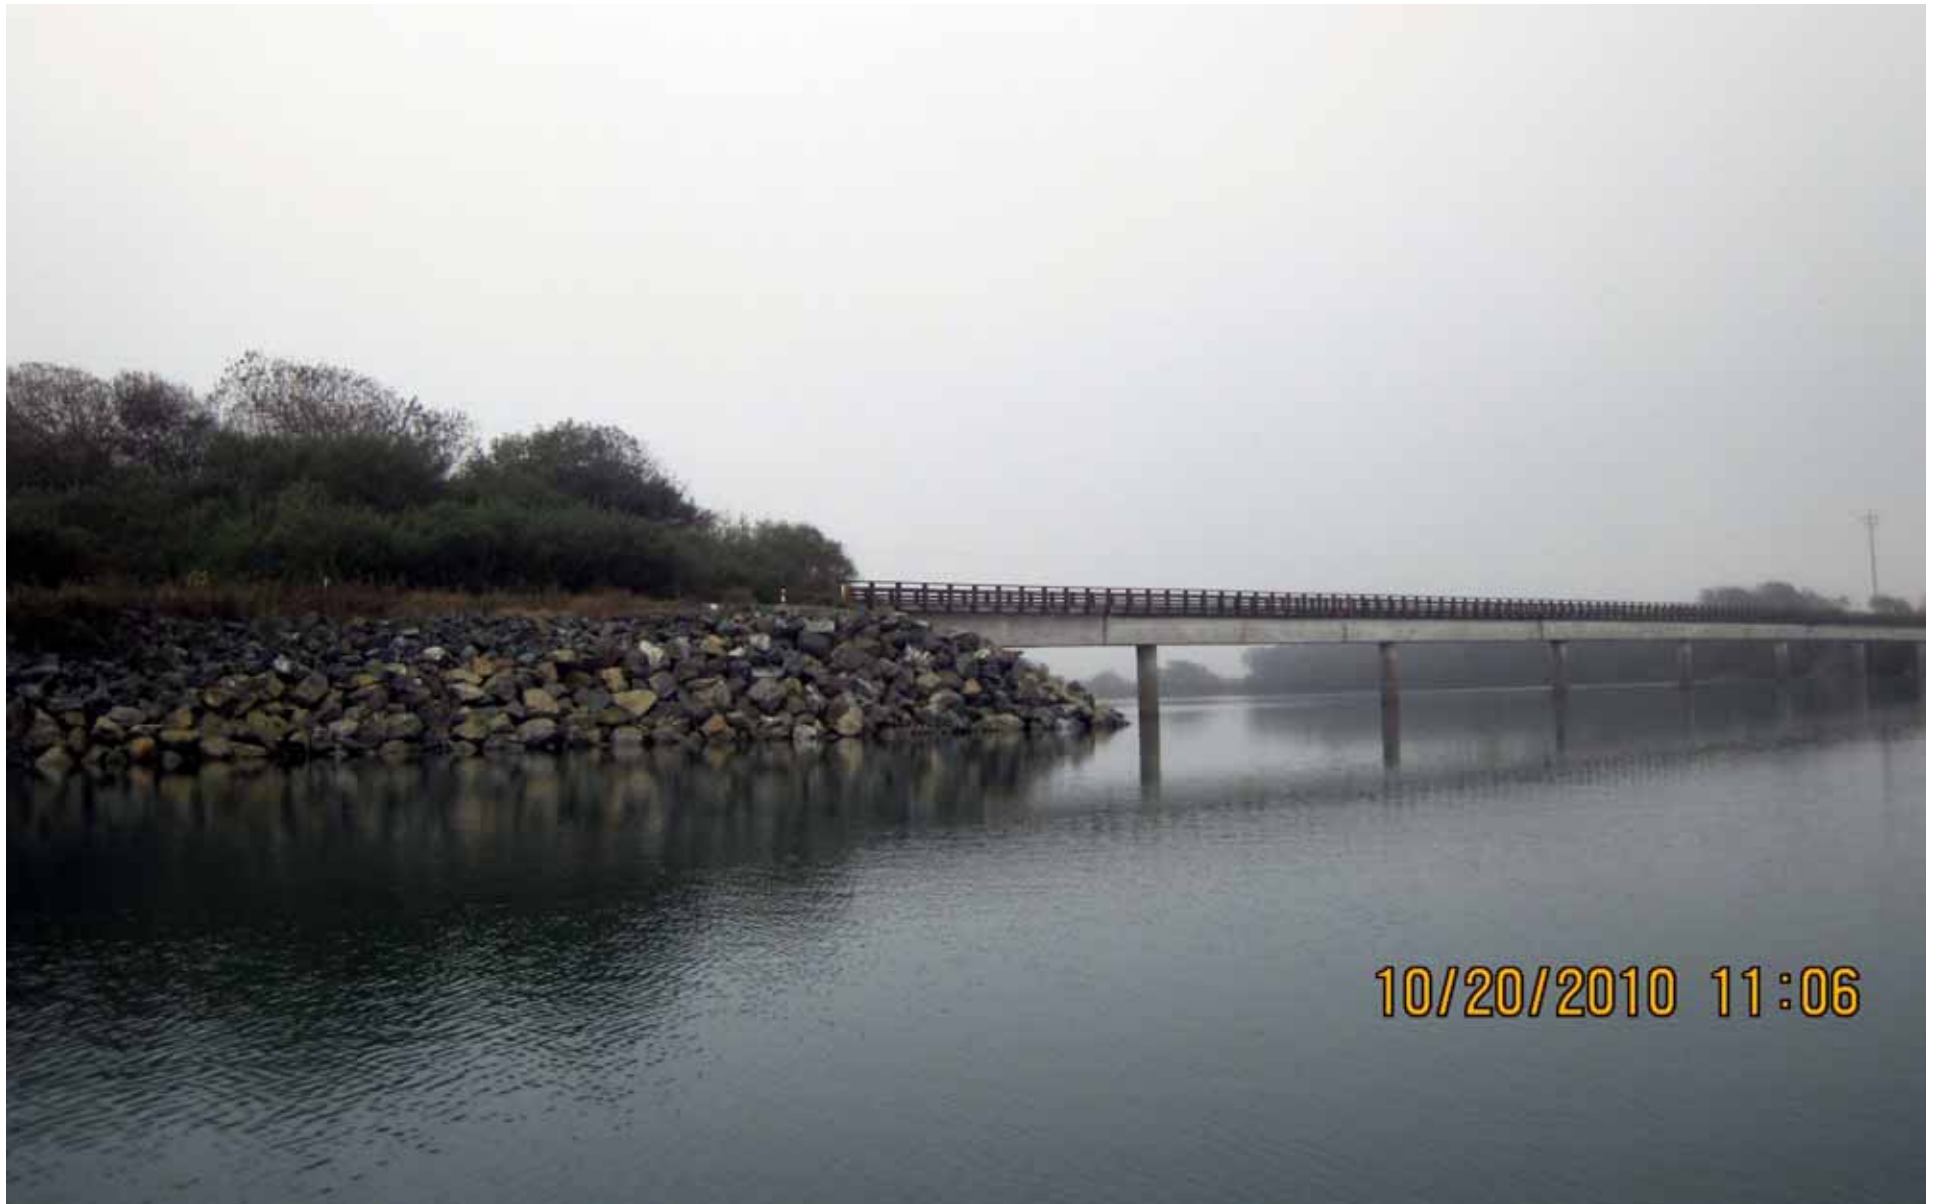
This photo of the Cock Robin Island Bridge looking downstream shows that the island side foundation (at left) is being protected by large boulders or rip rap. This causes scour forces in the channel here that help maintain depth.

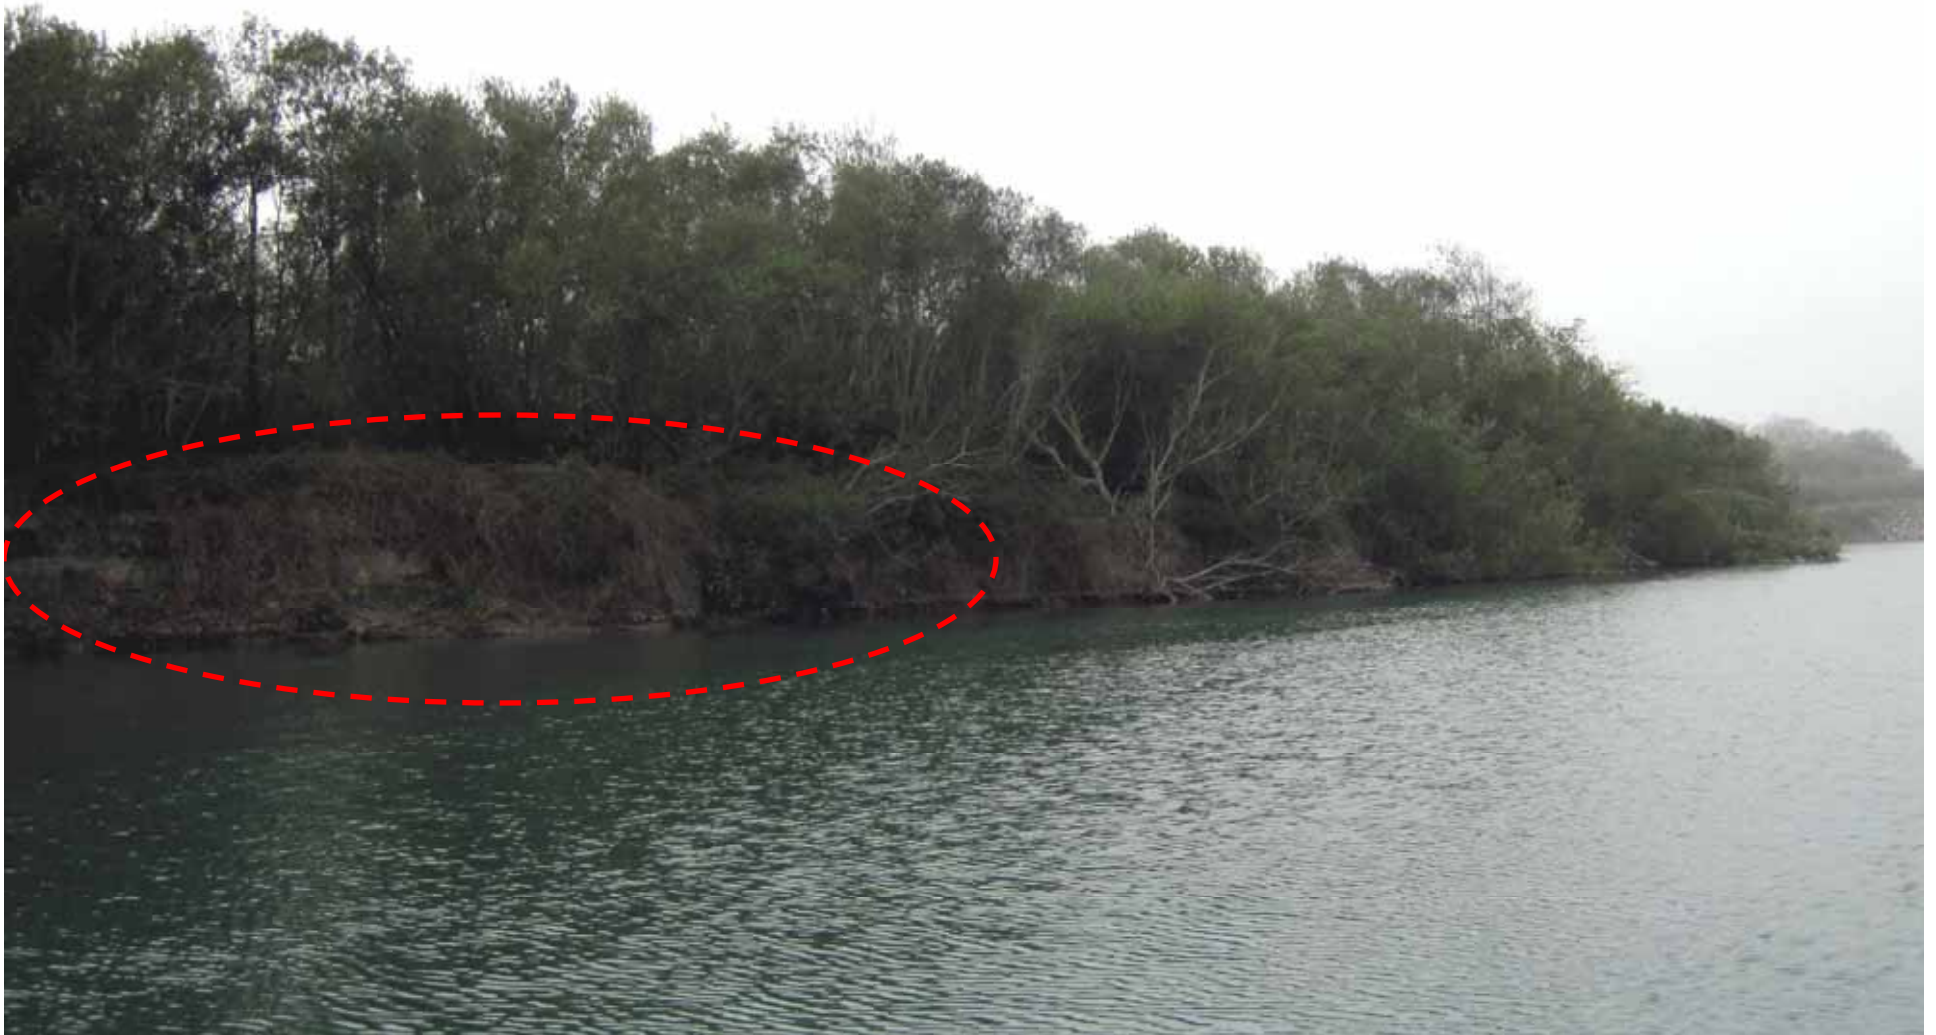
This riparian view is of the north side of the main estuary channel above the Cock Robin Island Bridge. Alders here are growing in soil above salt influence, but old dead trees in the water probably succumbed from salt exposure. The dead falls help increase habitat complexity for fish here.

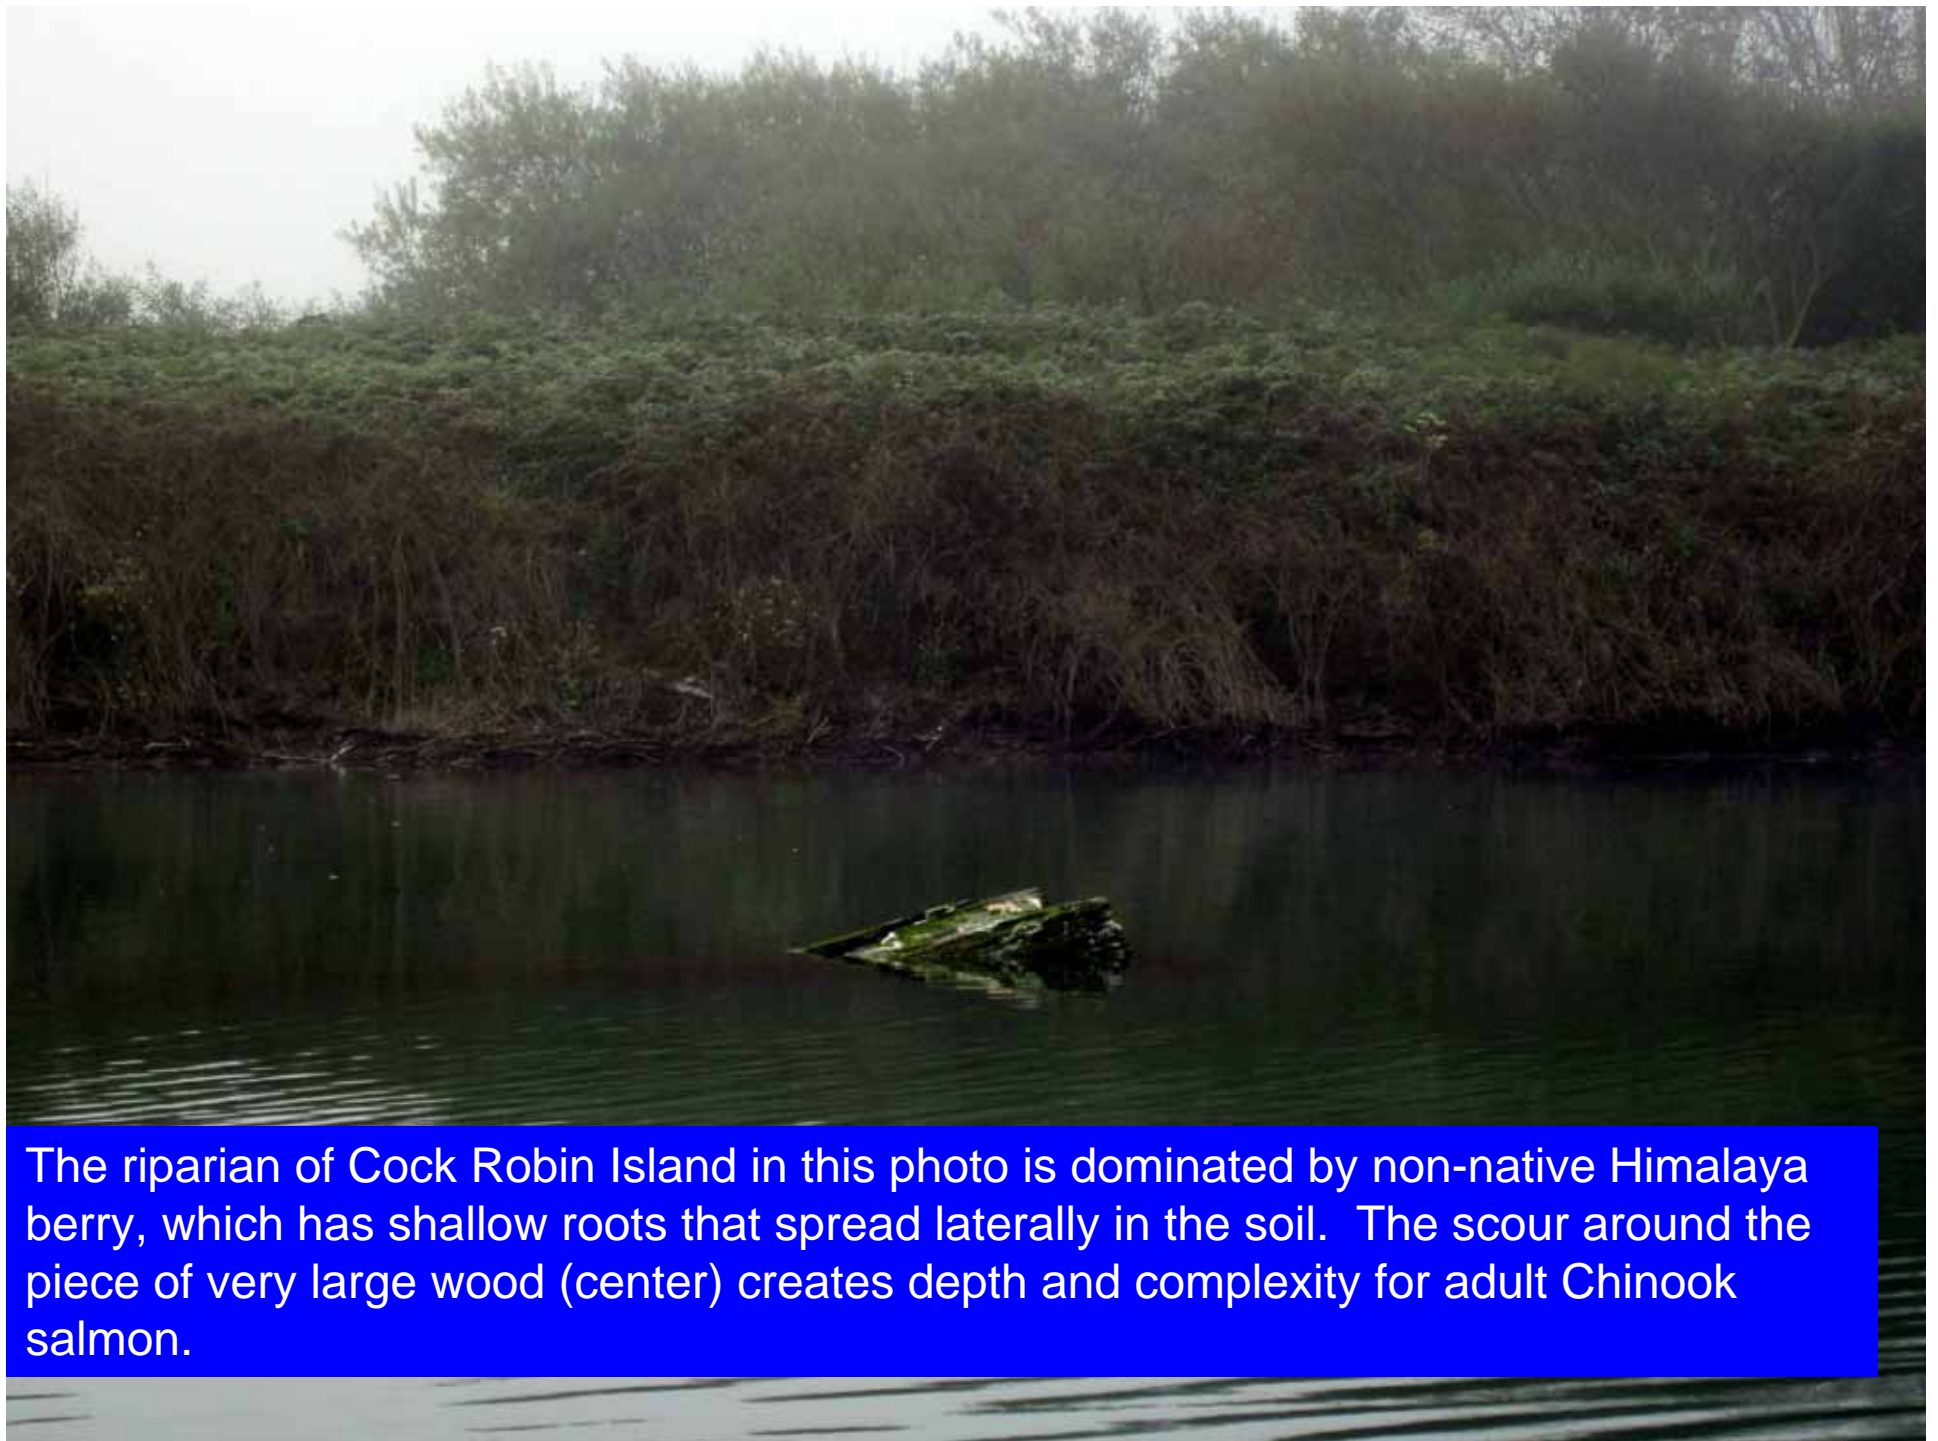
The riparian of Cock Robin Island in this photo is dominated by non-native Himalaya berry, which has shallow roots that spread laterally in the soil. The scour around the piece of very large wood (center) creates depth and complexity for adult Chinook salmon.

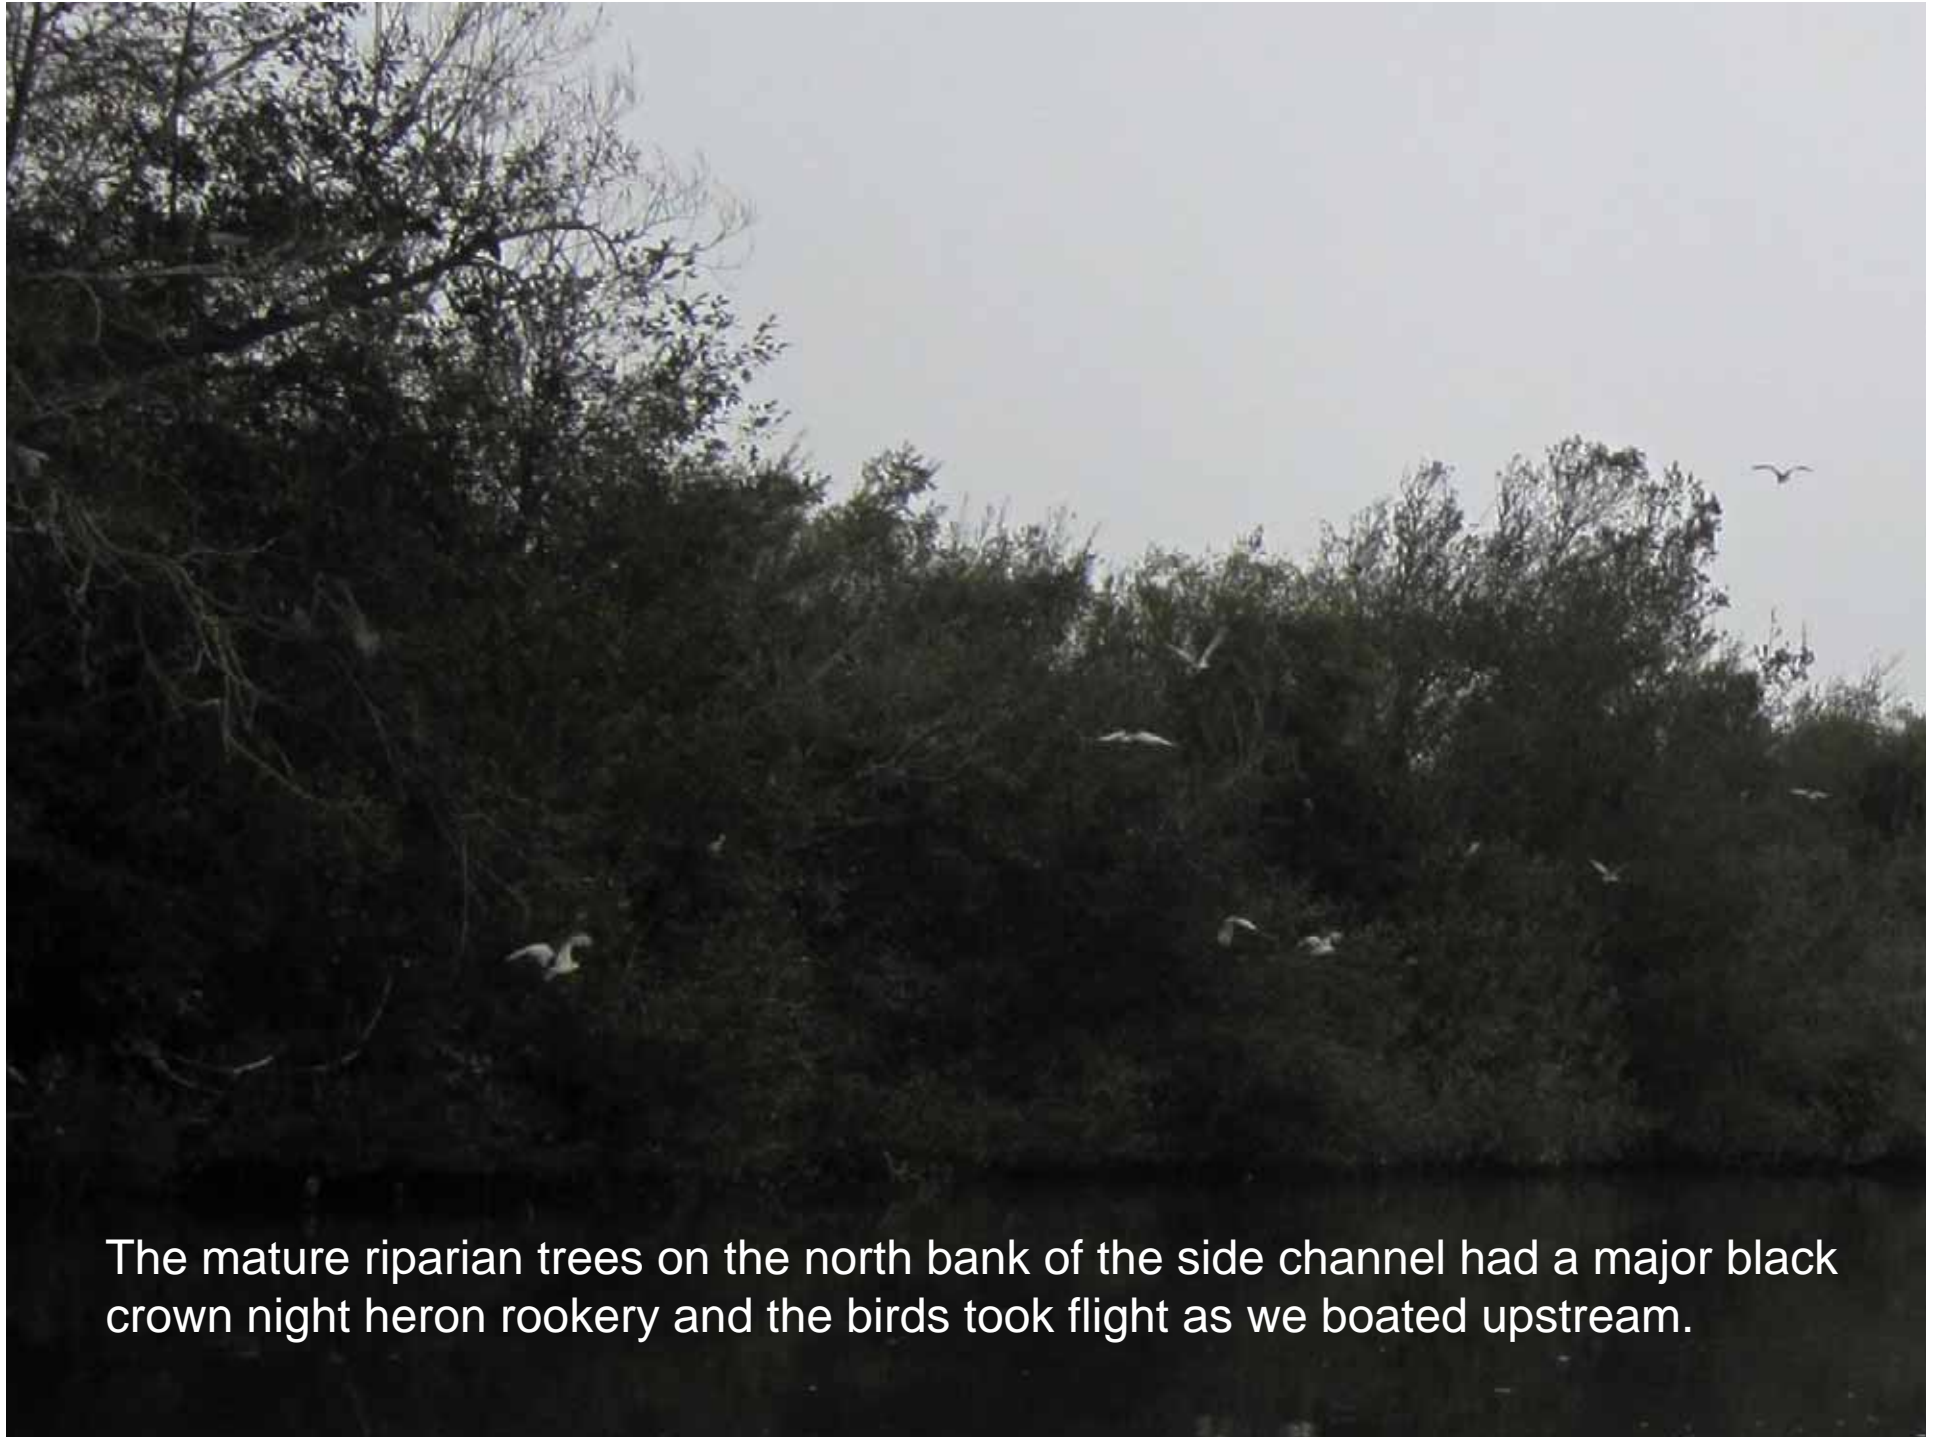
The mature riparian trees on the north bank of the side channel had a major black crown night heron rookery and the birds took flight as we boated upstream.

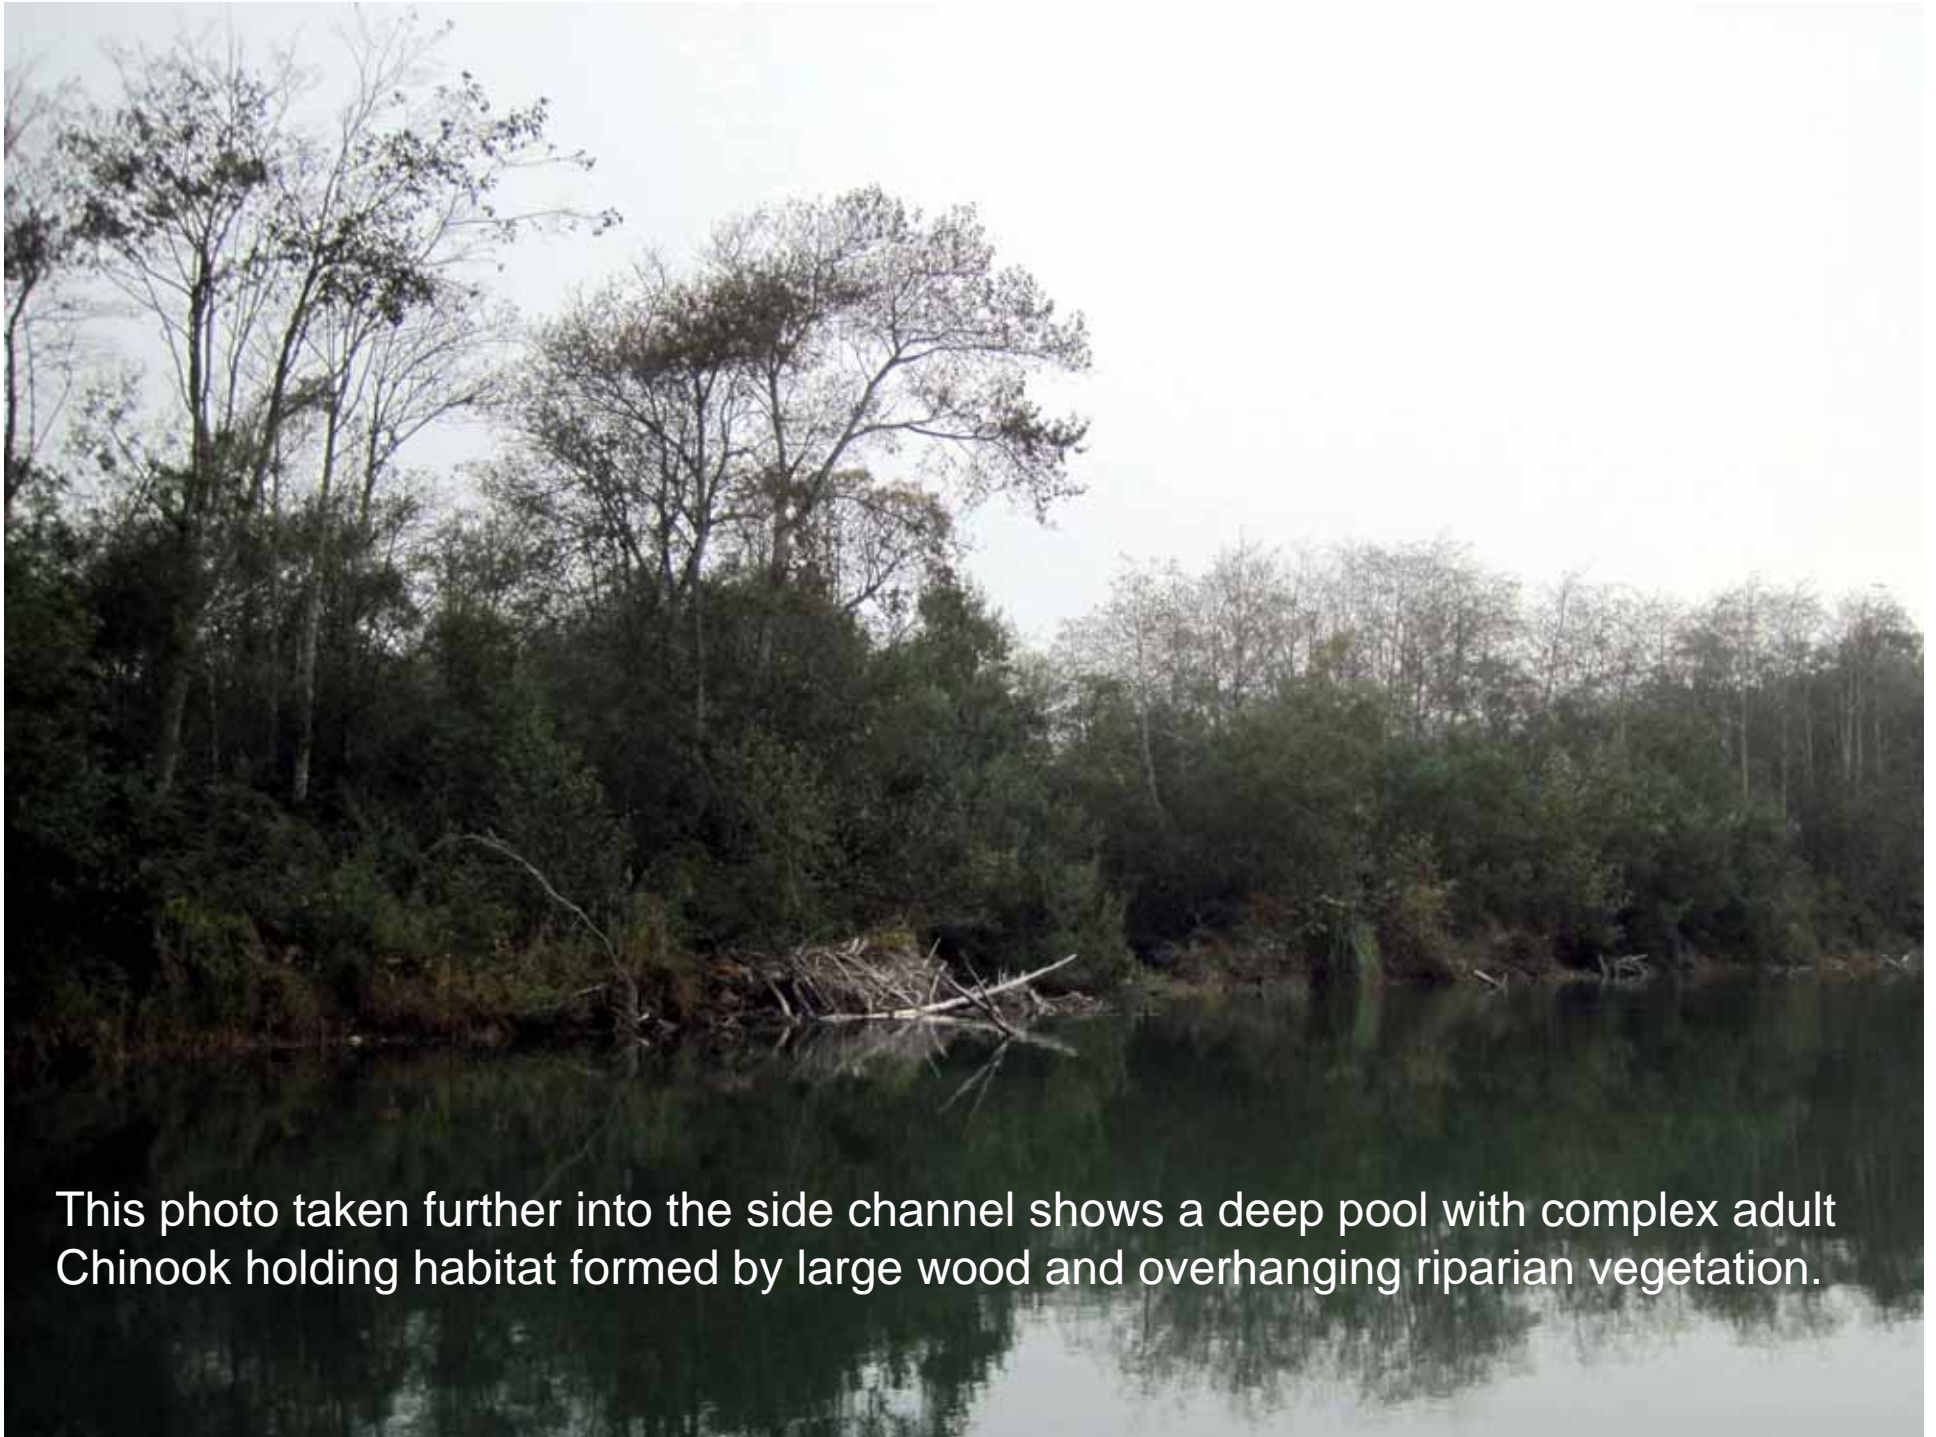
This photo taken further into the side channel shows a deep pool with complex adult Chinook holding habitat formed by large wood and overhanging riparian vegetation.

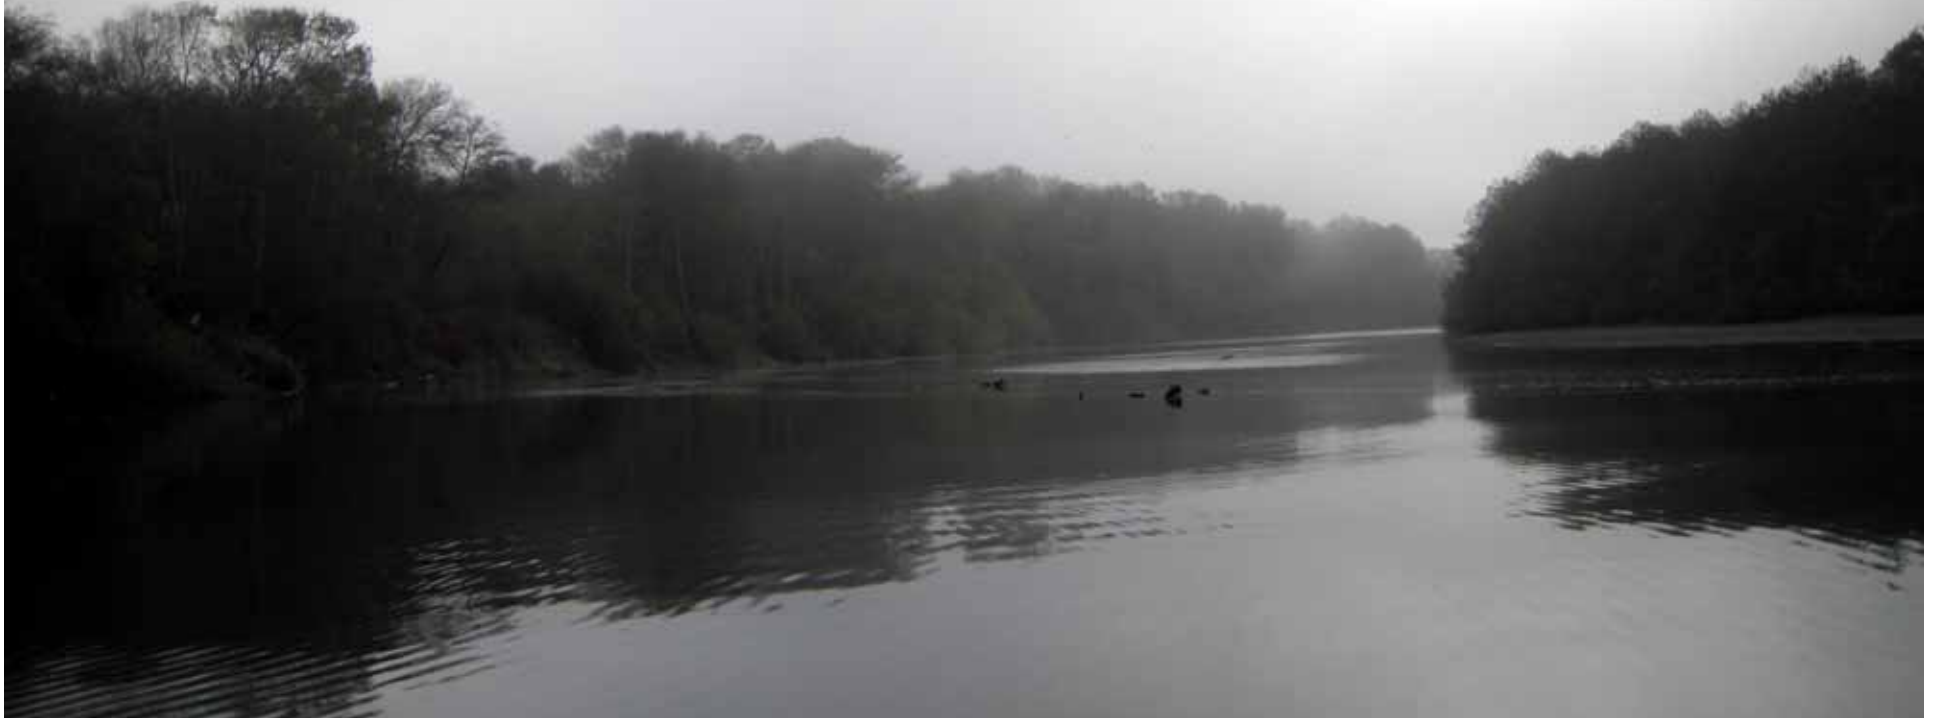
This view is taken looking upstream in the side channel from the highest point to which we traveled. A mass of sediment was deposited in the distance in this photo that has caused the channel to shift.

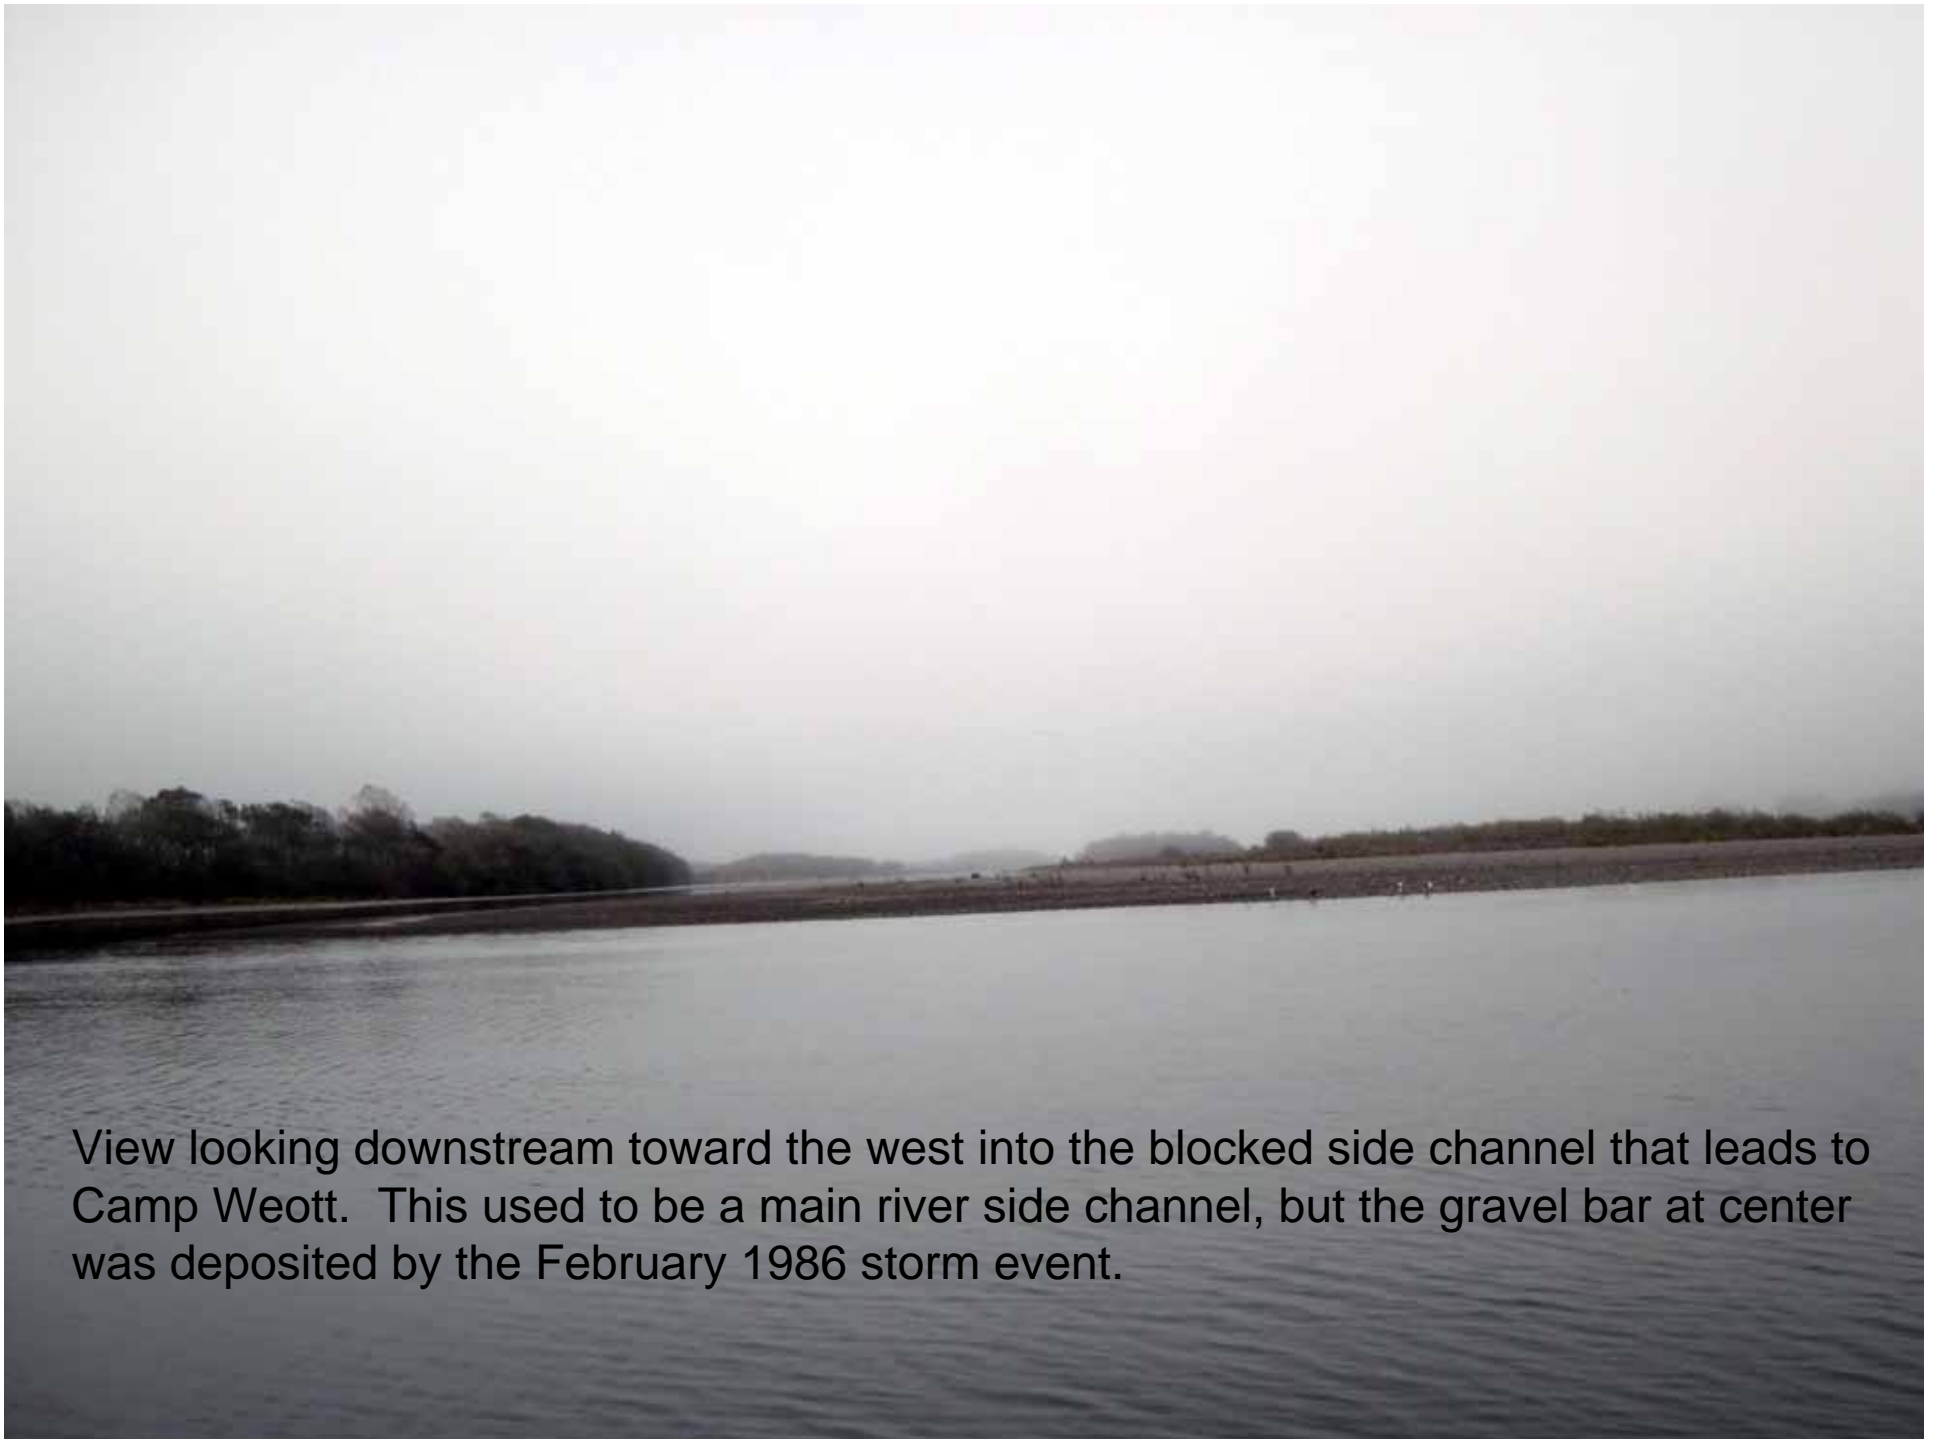
View looking downstream toward the west into the blocked side channel that leads to Camp Weott. This used to be a main river side channel, but the gravel bar at center was deposited by the February 1986 storm event.

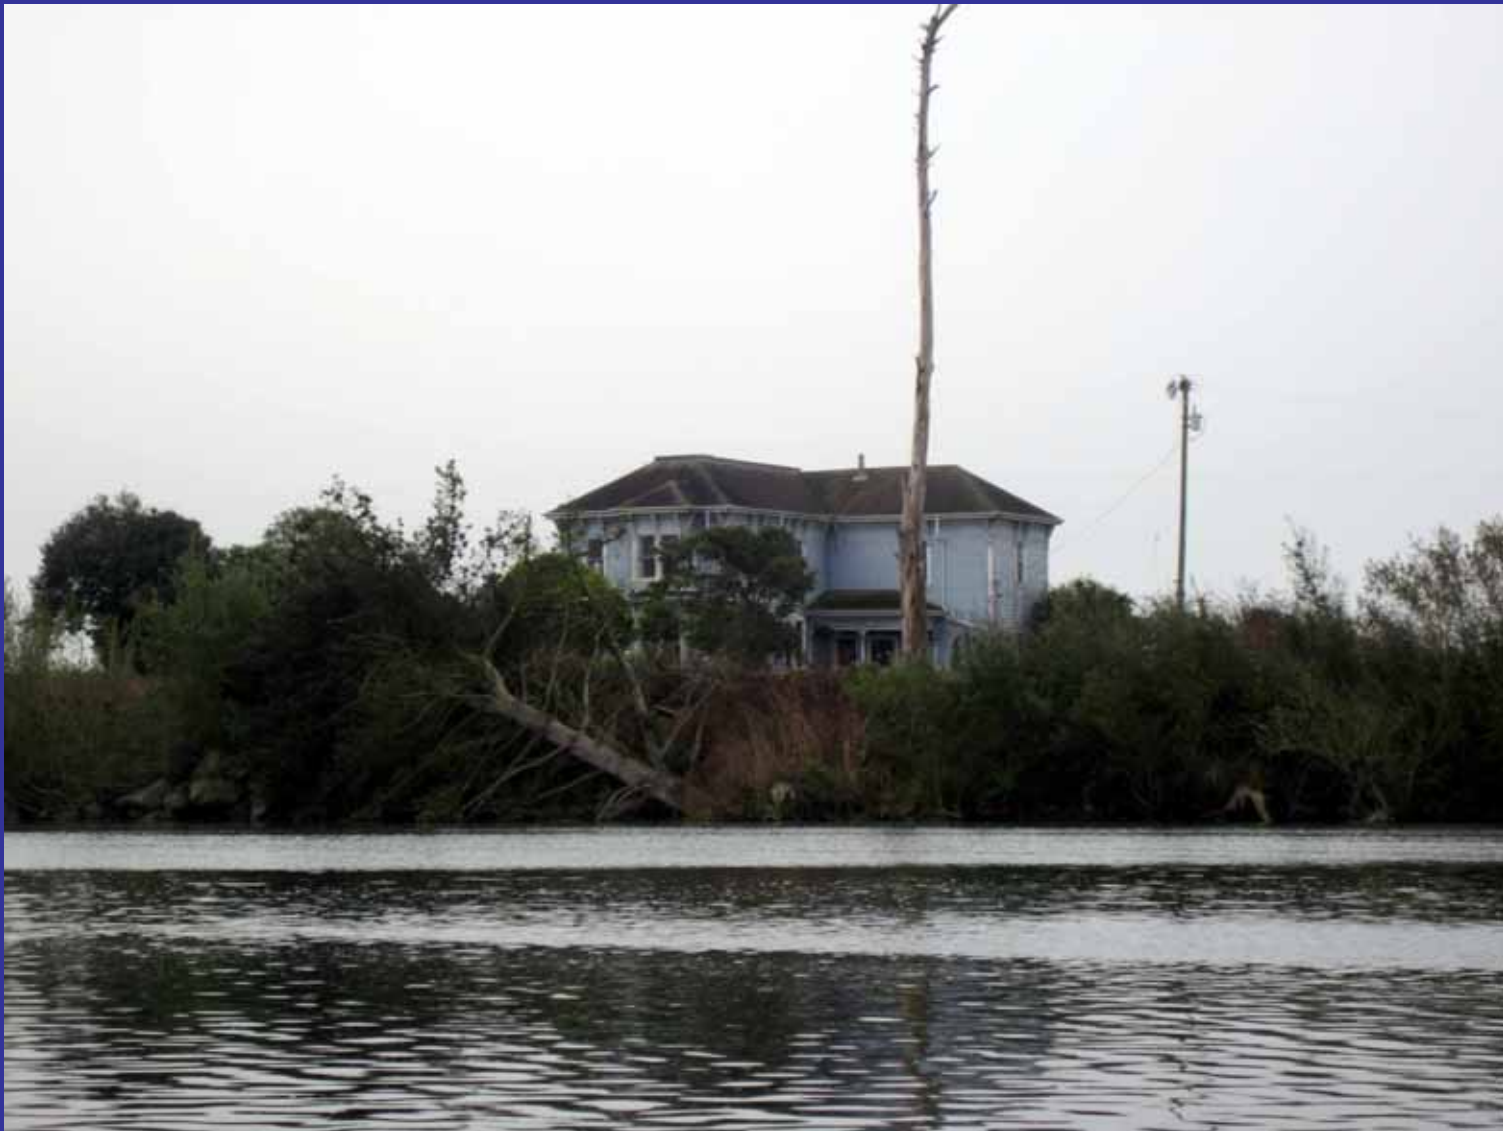
The Fulmore House sits adjacent to the estuary on Fulmore Road and marks the upper limit of legal fishing. The large riparian conifer that has toppled towards the water will likely provide good cover for fish if it washes in. The standing dead snag likely indicates that the trees roots reached salt water.

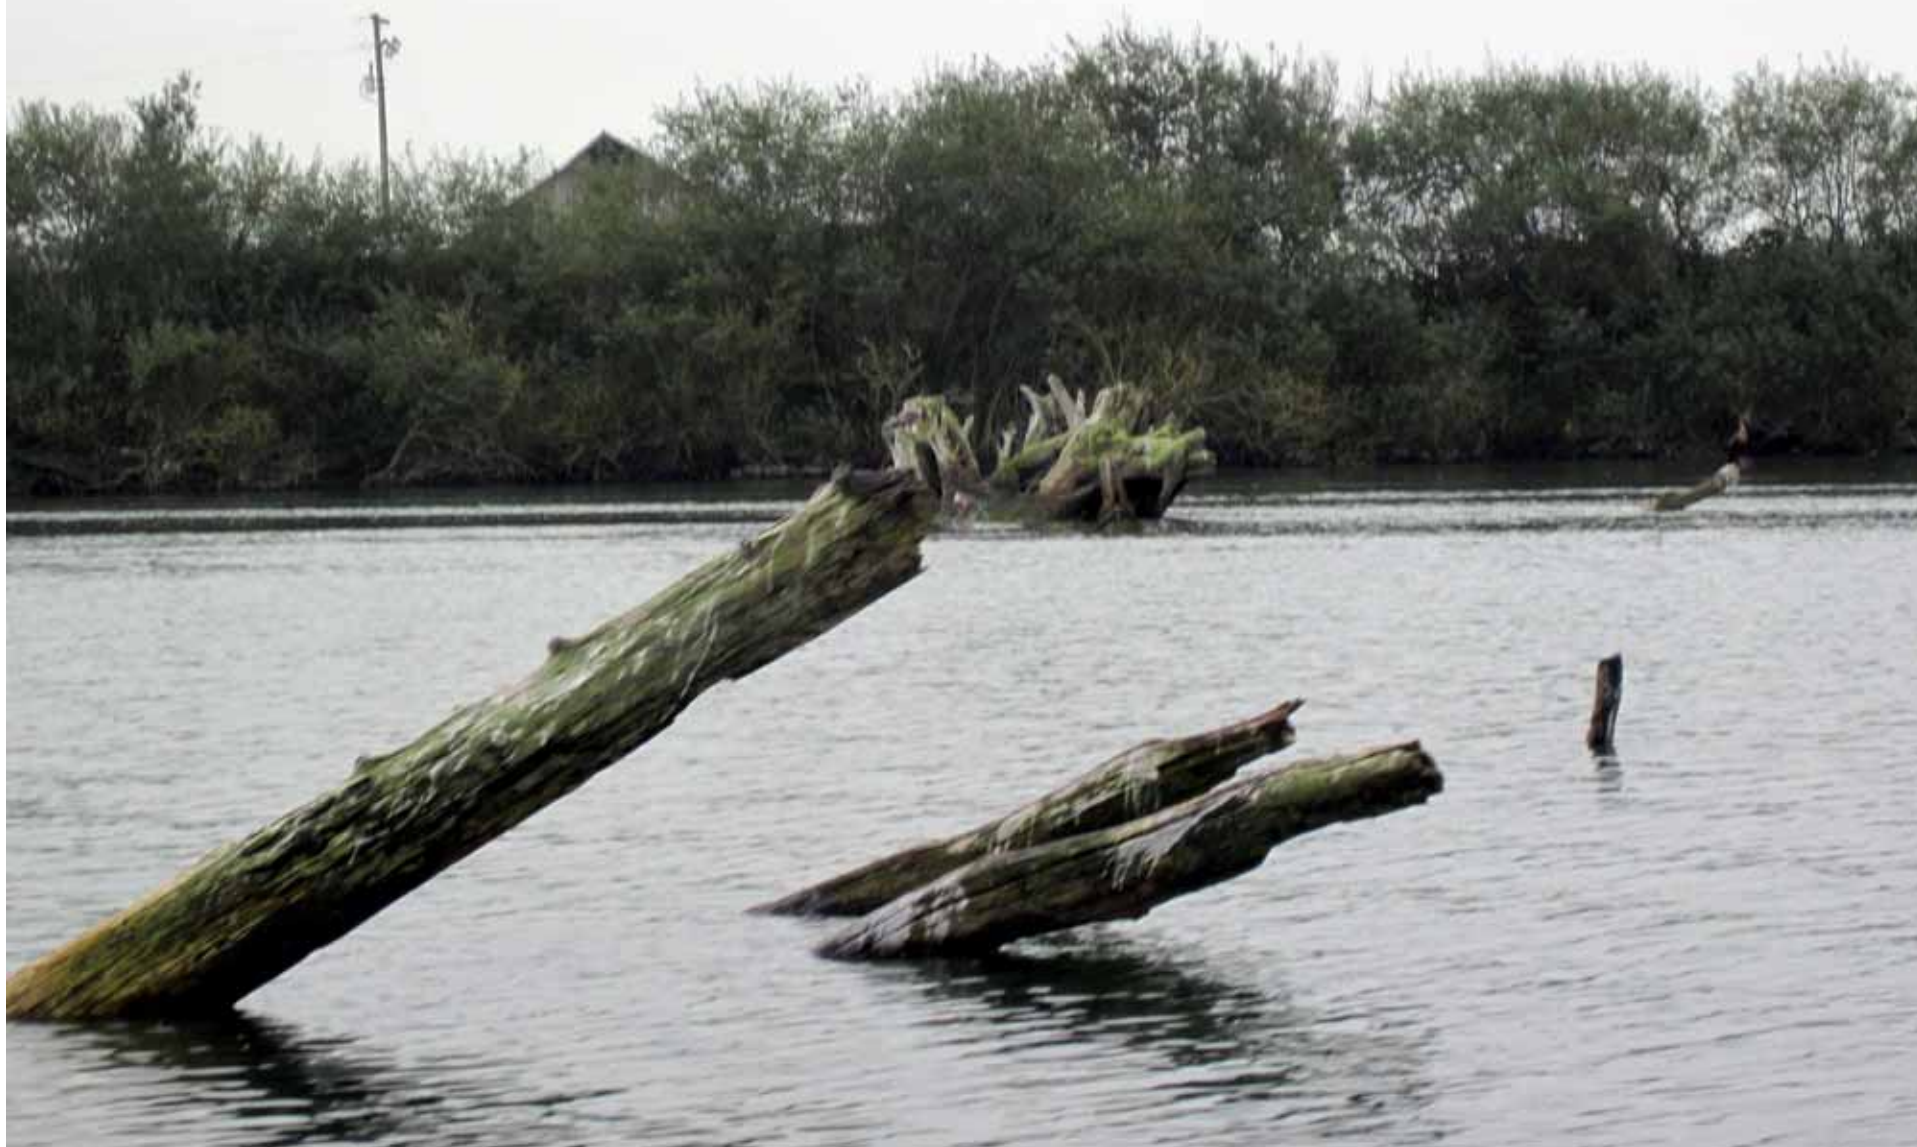
Large wood embedded in the channel in the Fulmore Pool creates scour that maintains depth and also provides cover for adult Chinook salmon that would help them avoid seal predation.

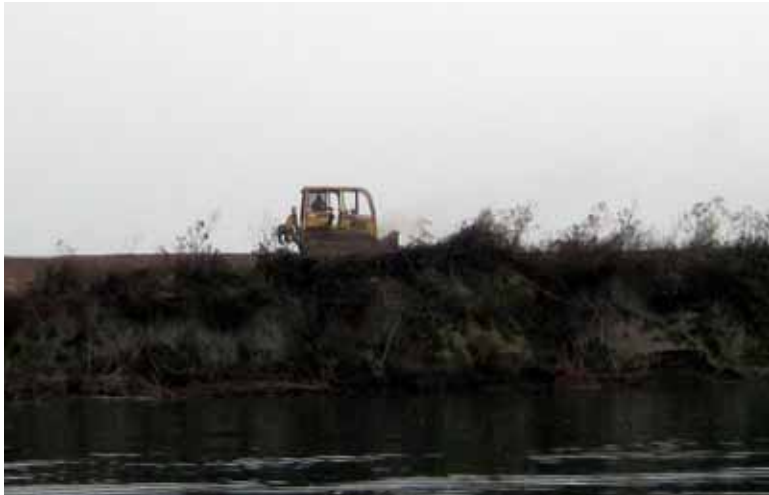
Just downstream of the large side channel and above the Cock Robin Island Bridge, a levee was damaged by high flows in 2006. The necessary repairs were just begun this year and work was still active on the day of our tour.
