# **Friends of Eel Fall Chinook Monitoring Project**

**Report #8**

**Are There Chinook in the Eel Estuary and What Is  
The Condition of Habitat?**

**October 20, 2010**

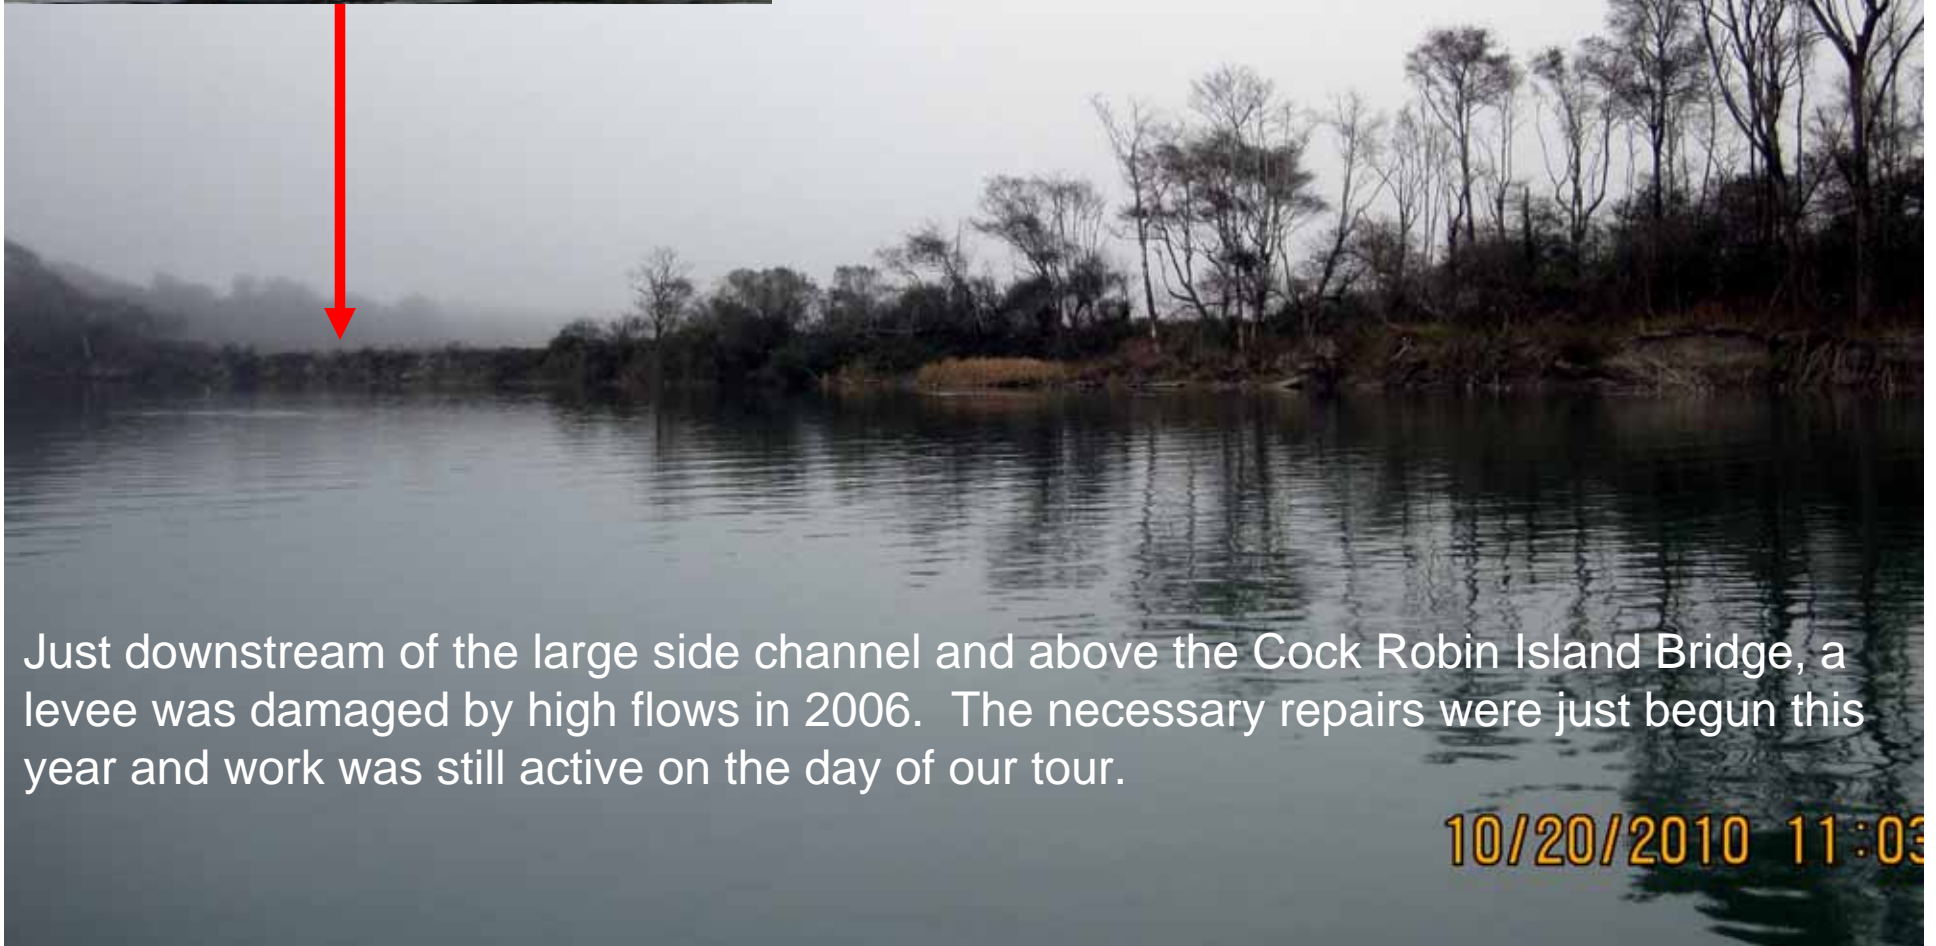
Just downstream of the large side channel and above the Cock Robin Island Bridge, a levee was damaged by high flows in 2006. The necessary repairs were just begun this year and work was still active on the day of our tour.

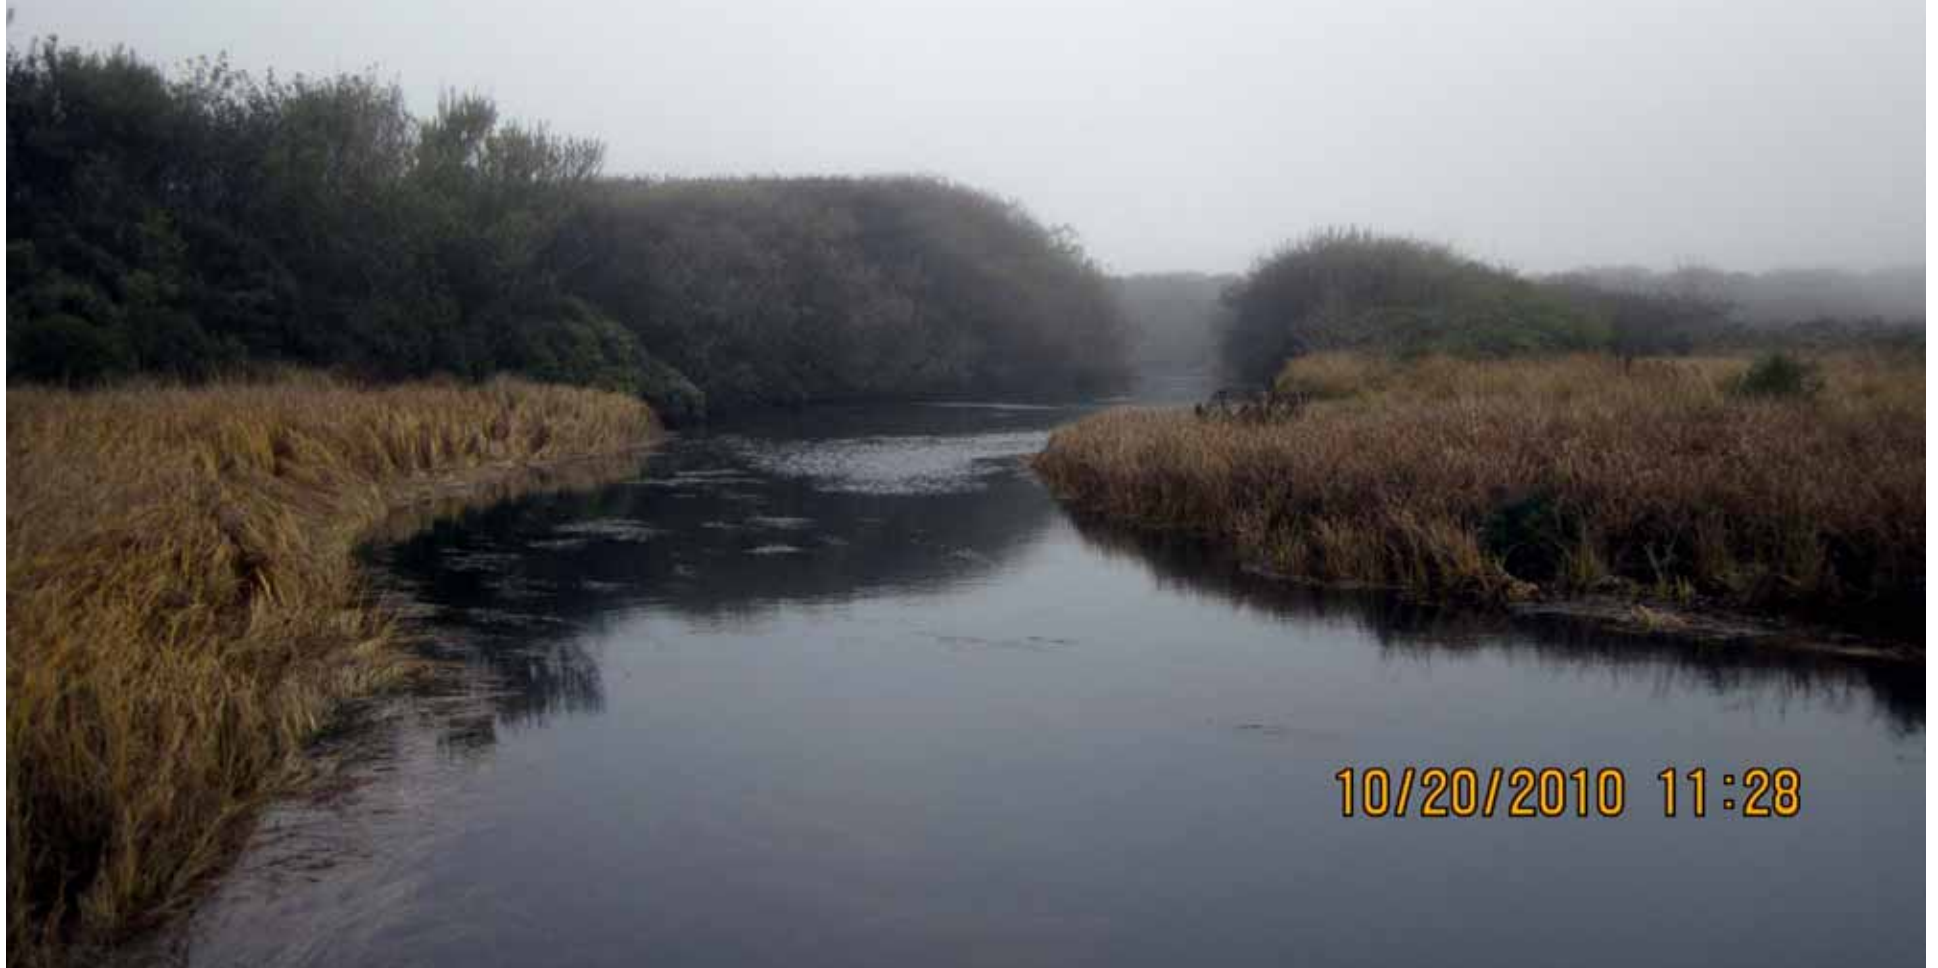
10/20/2010 11:28

We came back into an open channel area near the convergence of the old Salt River. This photo was taken looking up a slough arm to the south that leads to the Russ Creek tide gate.

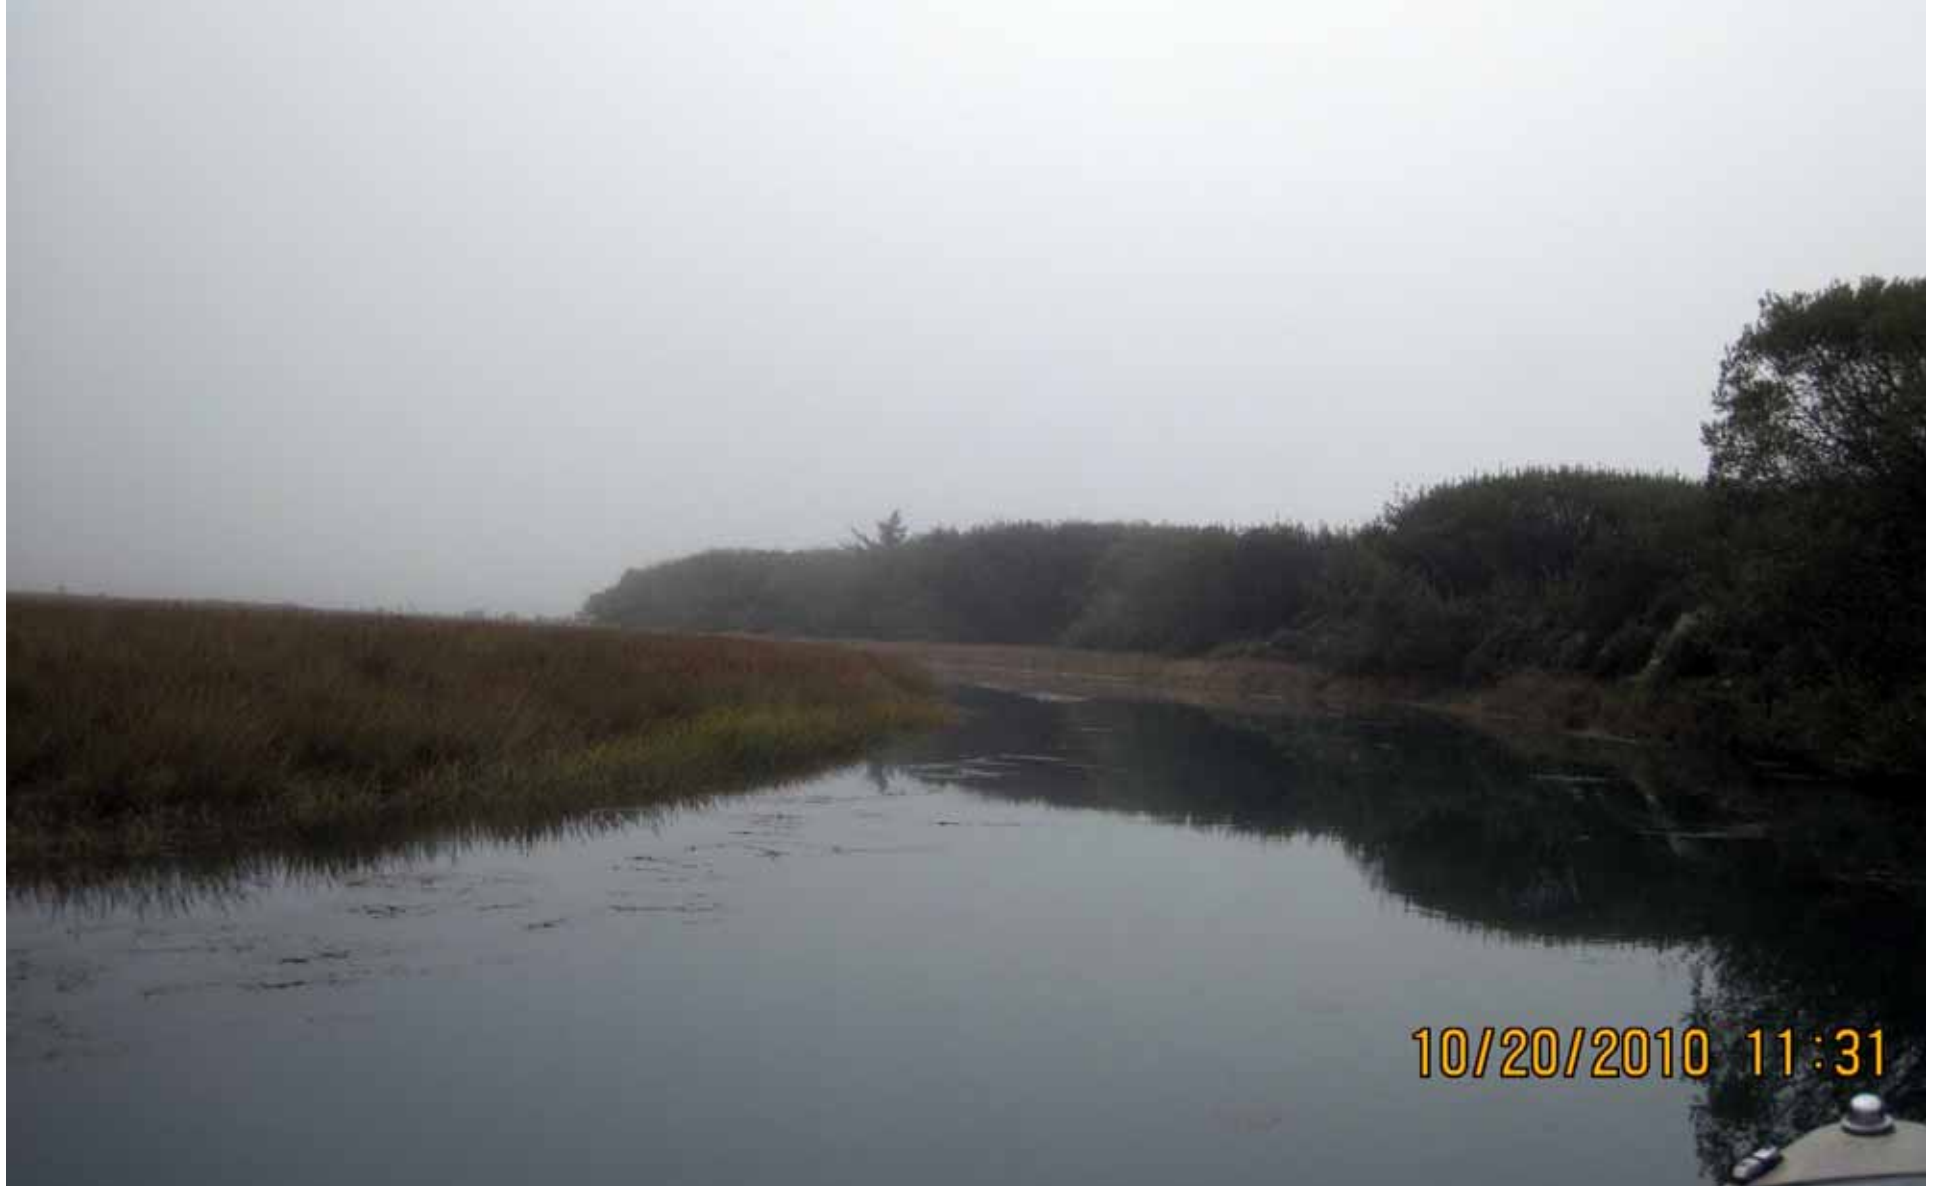
The straightened channel at right of center is the channel of the Salt River. There is a current, on-going project to reduce sediment and increase flood capacity from this point upstream.

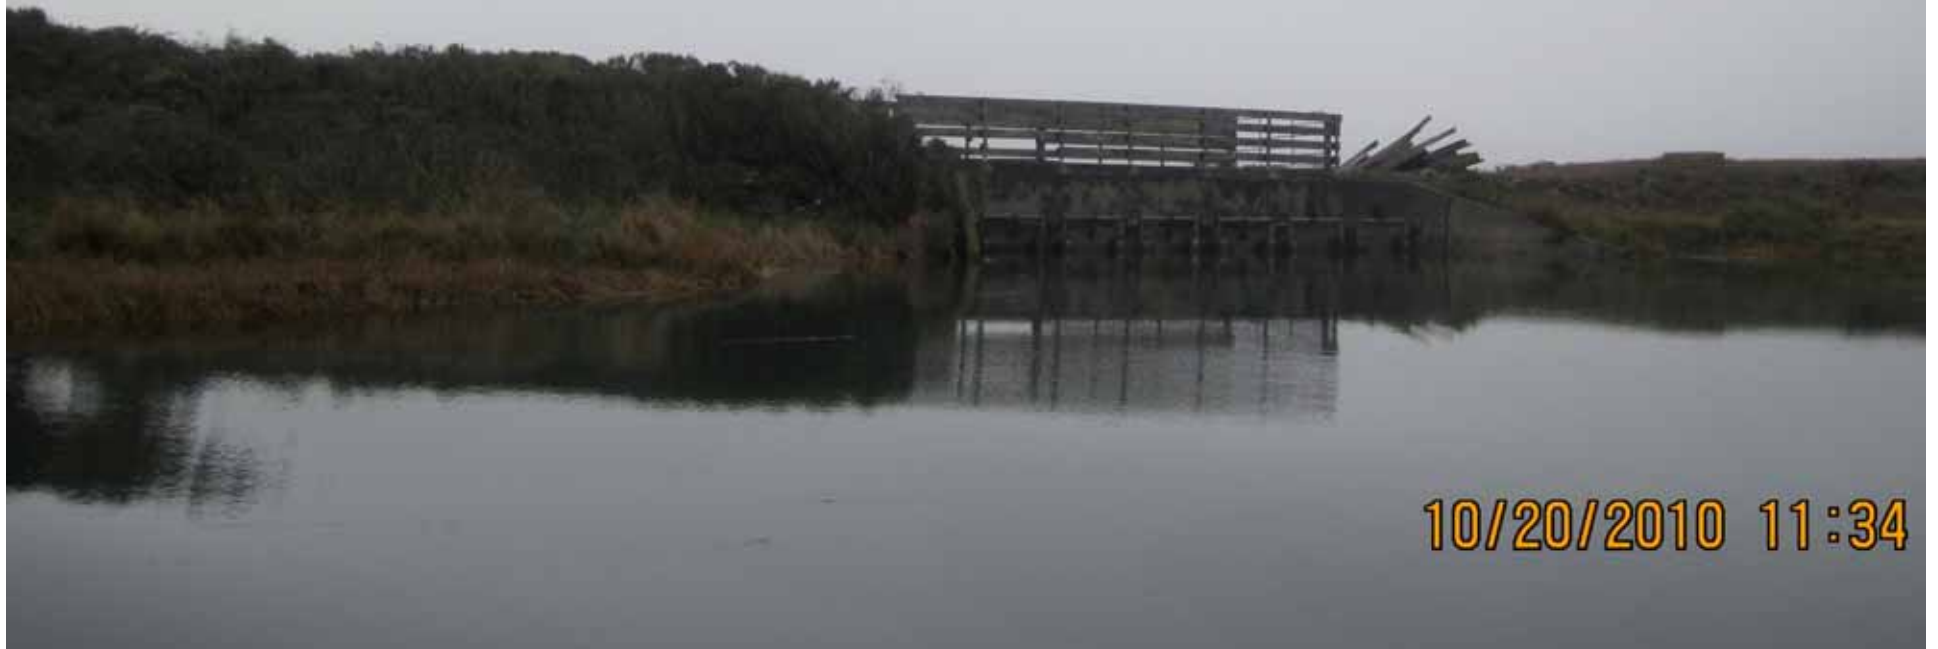
This photo was taken looking west towards the ocean at the Russ Creek tide gate at what was likely mud flats. Bruce talked about how diking in the estuary began in the 1880's and that shippers recognized potential problems with reducing flux, but were unsuccessful in challenging the practice. The tidal flats in this picture are covered with pickle weed and the non-native invasive species *Spartina*.

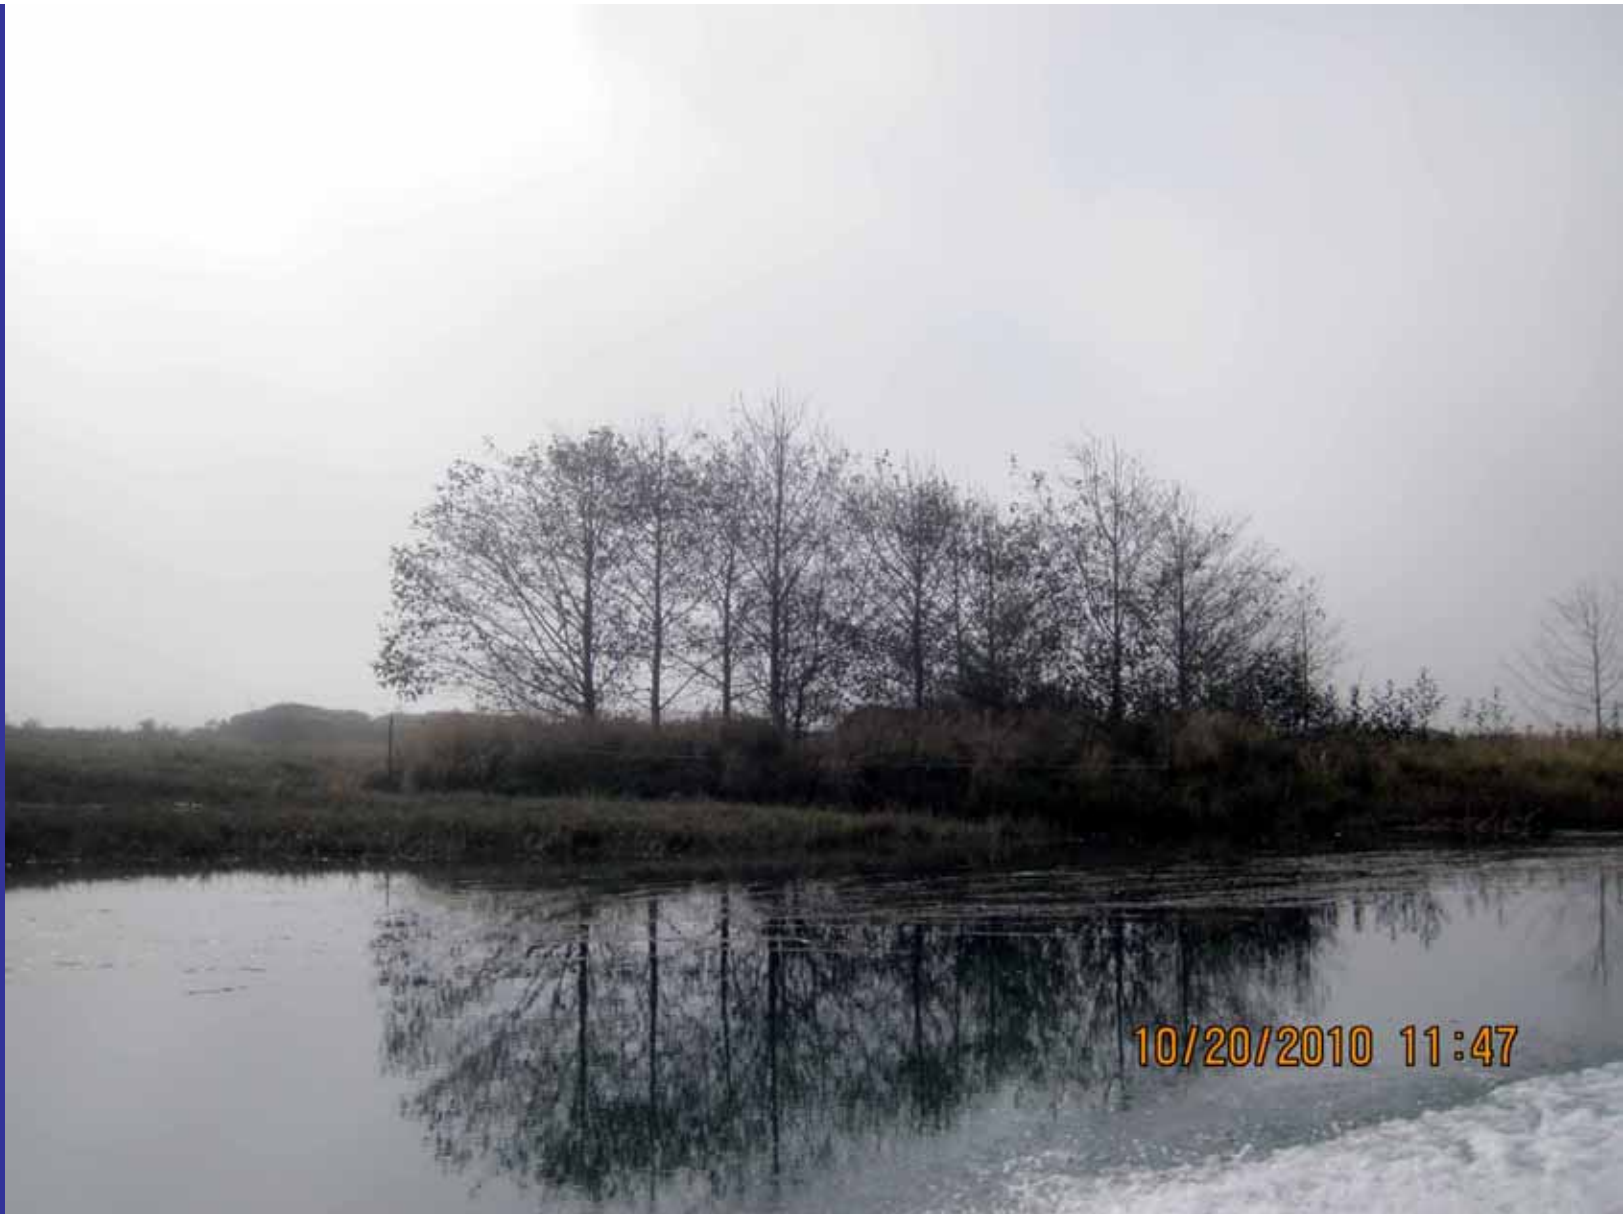
Bruce planted this alder grove near his duck blind, but only some trees took. Smaller trees to the right were also planted but are growing much more slowly, likely due to salt.

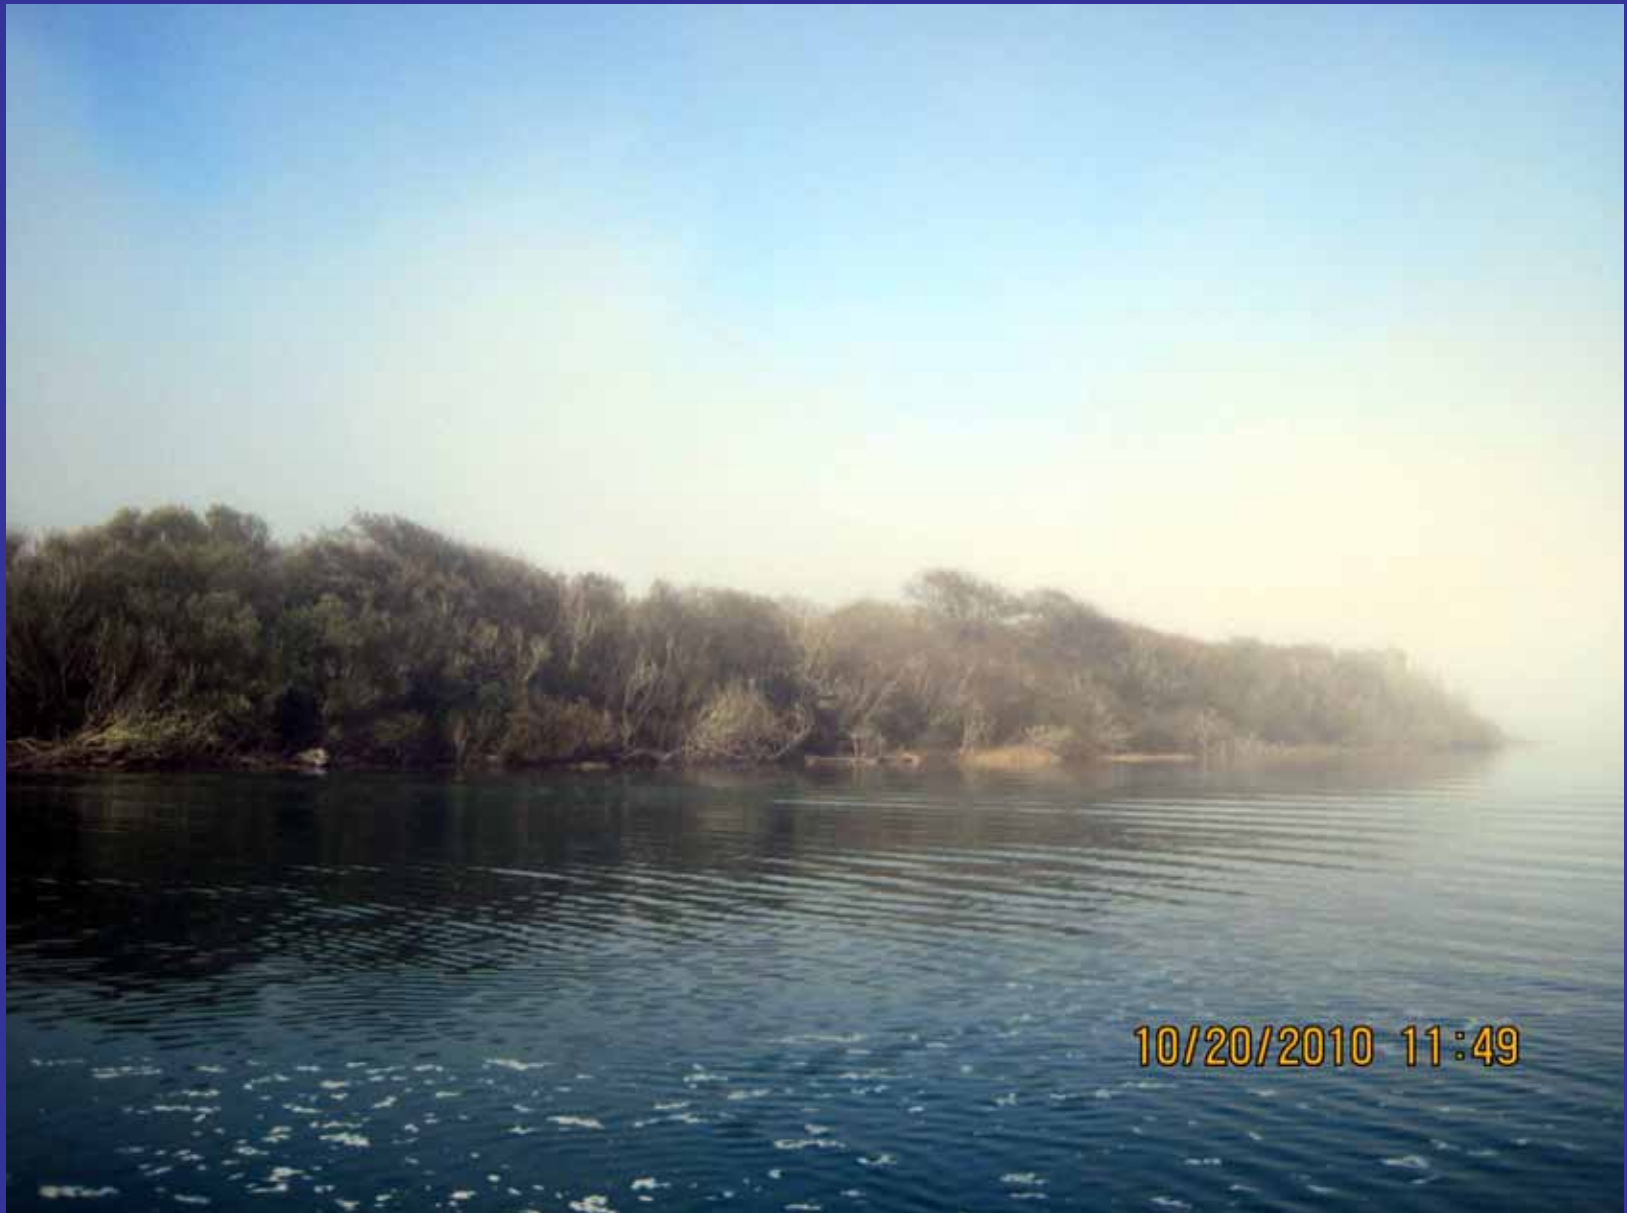
Looking downstream towards the mouth in the main Camp Weott side channel within a quarter mile of Bruce's dock.
